INDOOR AIR QUALITY ASSESSMENT

**Joseph P. DeMello Elementary School
654 Dartmouth Street
Dartmouth, Massachusetts**

Prepared by:
Massachusetts Department of Public Health
Bureau of Environmental Health Assessment
July, 2002

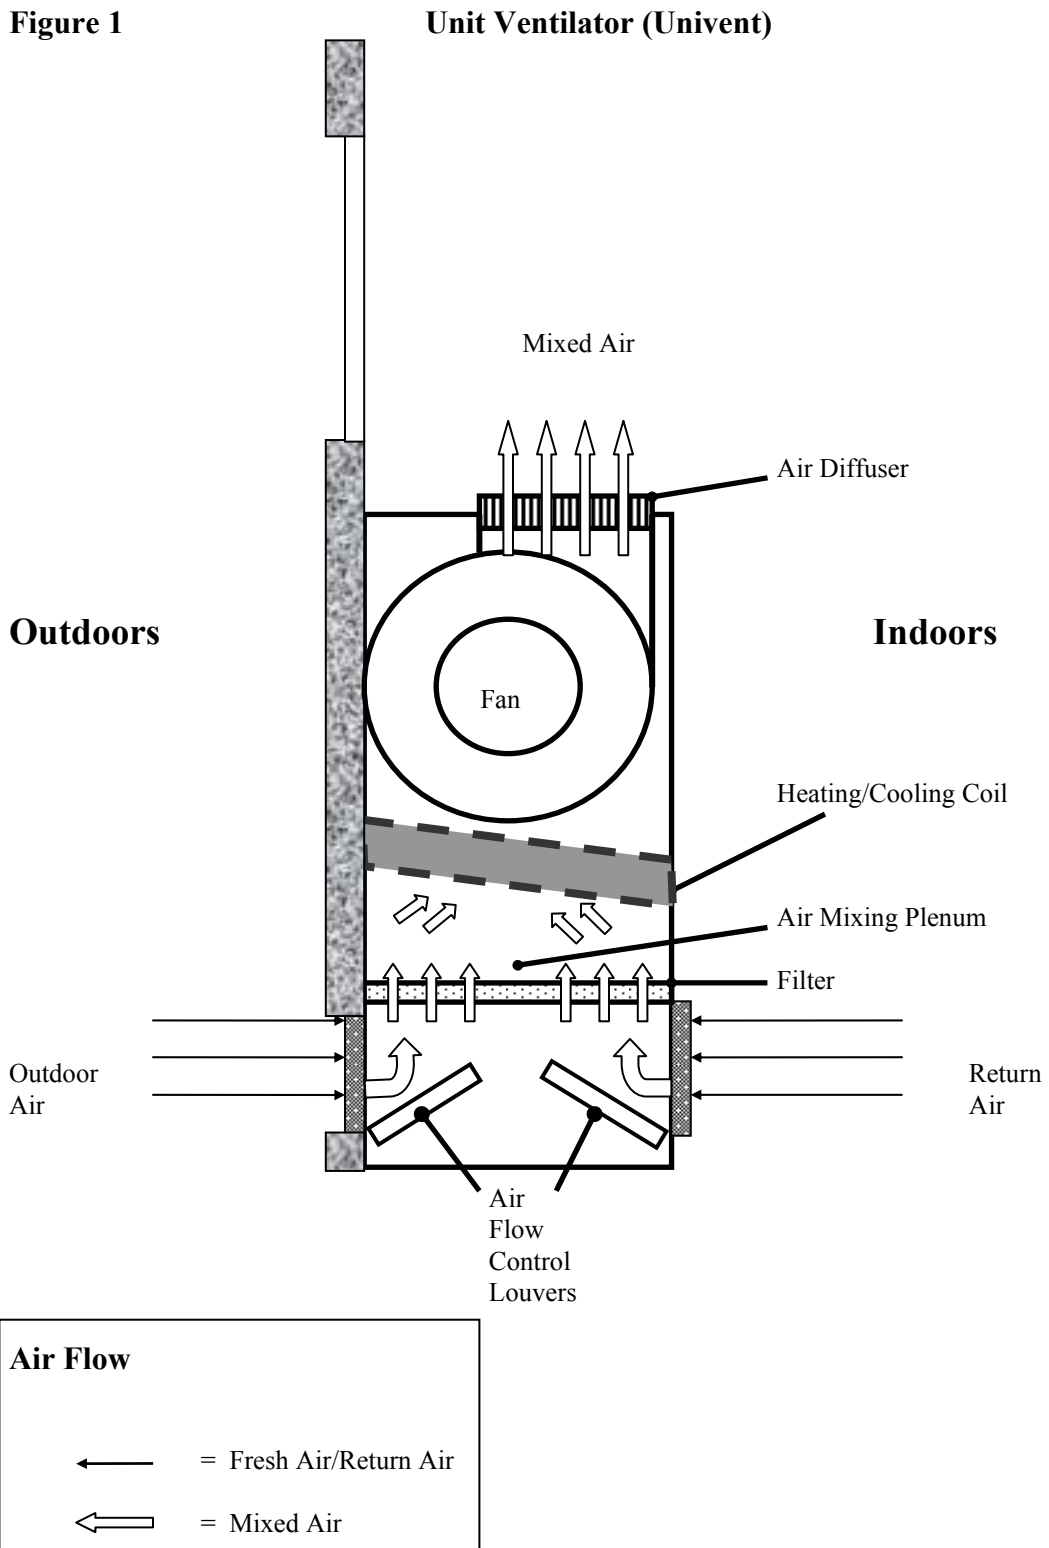
Figure 1

Fresh air in classrooms is supplied by wall-mounted unit ventilators (univents) (see [Figure 1](#)). Univents draw air from outdoors through a fresh air intake located on the exterior walls of the building and return air through an air intake located at the base of each unit. The mixture of fresh and return air is drawn through a filter and a heating coil, and is then expelled from the univent by motorized fans through fresh air diffusers.
